Form: Application for Investigation  
Part V, *Environmental Bill of Rights*, 1993

## **SCHEDULE 1 – Excavation Below Water Table Limits**

#### **SCHEDULE 4 – Unregulated Filling, Draining, Etc.**

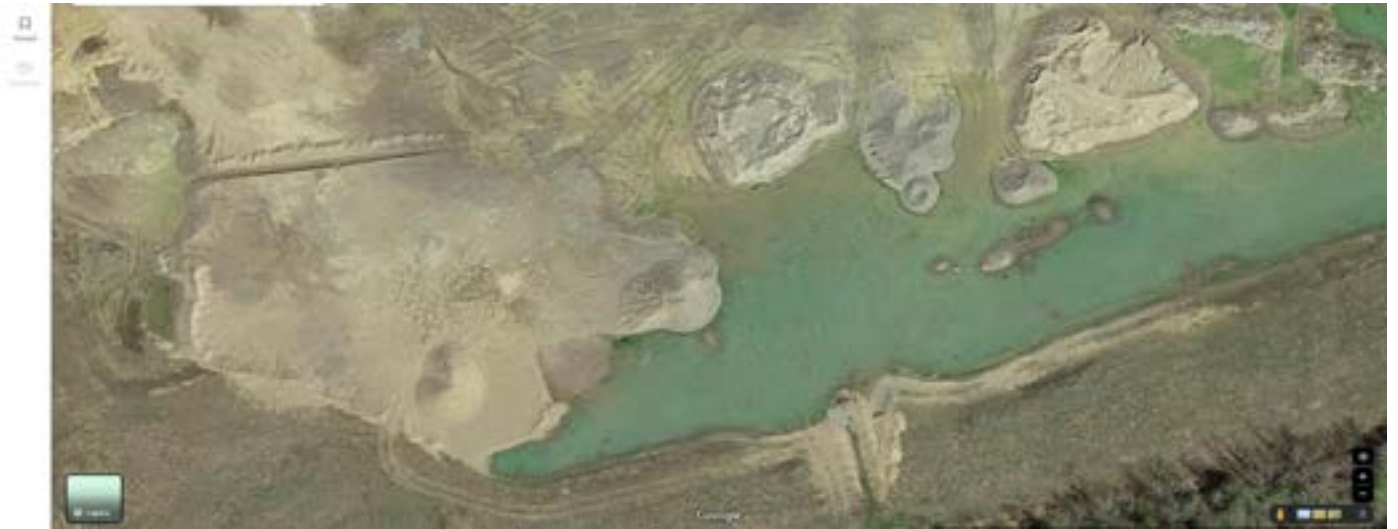
#### 4.1 Ariel Photograph May 7, 2018 (Google)

- 4.1 This aerial photograph is dated May 7, 2018 and shows that (among other activities) at some stage prior to that date a ditch had been dug between the large surface pool and the southern boundary of the Property. This was apparently being used to drain the water from the surface pool to the south, which would be directly into the Biddy Creek Conservation Area, the Little Lake catchment area, and towards the water basin for the Town of Colborne. This feature is not apparent on the earlier photographs at Schedules 1.1-1.3. We believe these and later efforts to lower the level of the surface pooling were in part a response to multiple neighbor complaints made because children were accessing the Property and swimming in the surface pools. We understand that some of these complaints reported the depth of the water to be 5-6 ft (1.5-1.8 metres).

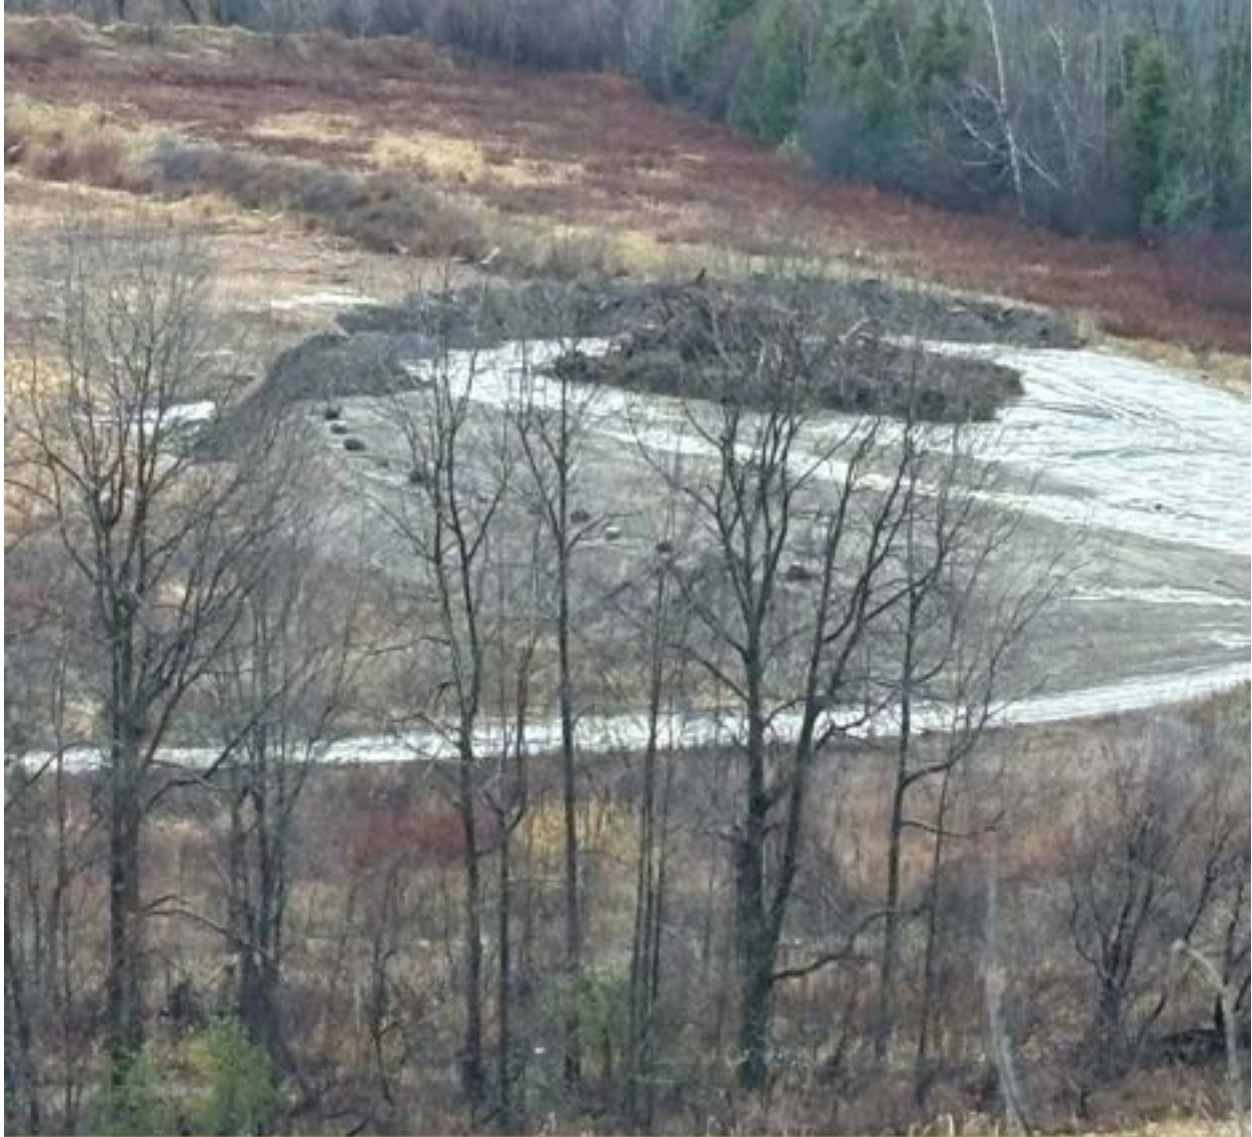
4.3.1 Picture taken November 22<sup>nd</sup> 2024 shows the extensive buildup of fill, rubble, trees, and brush.

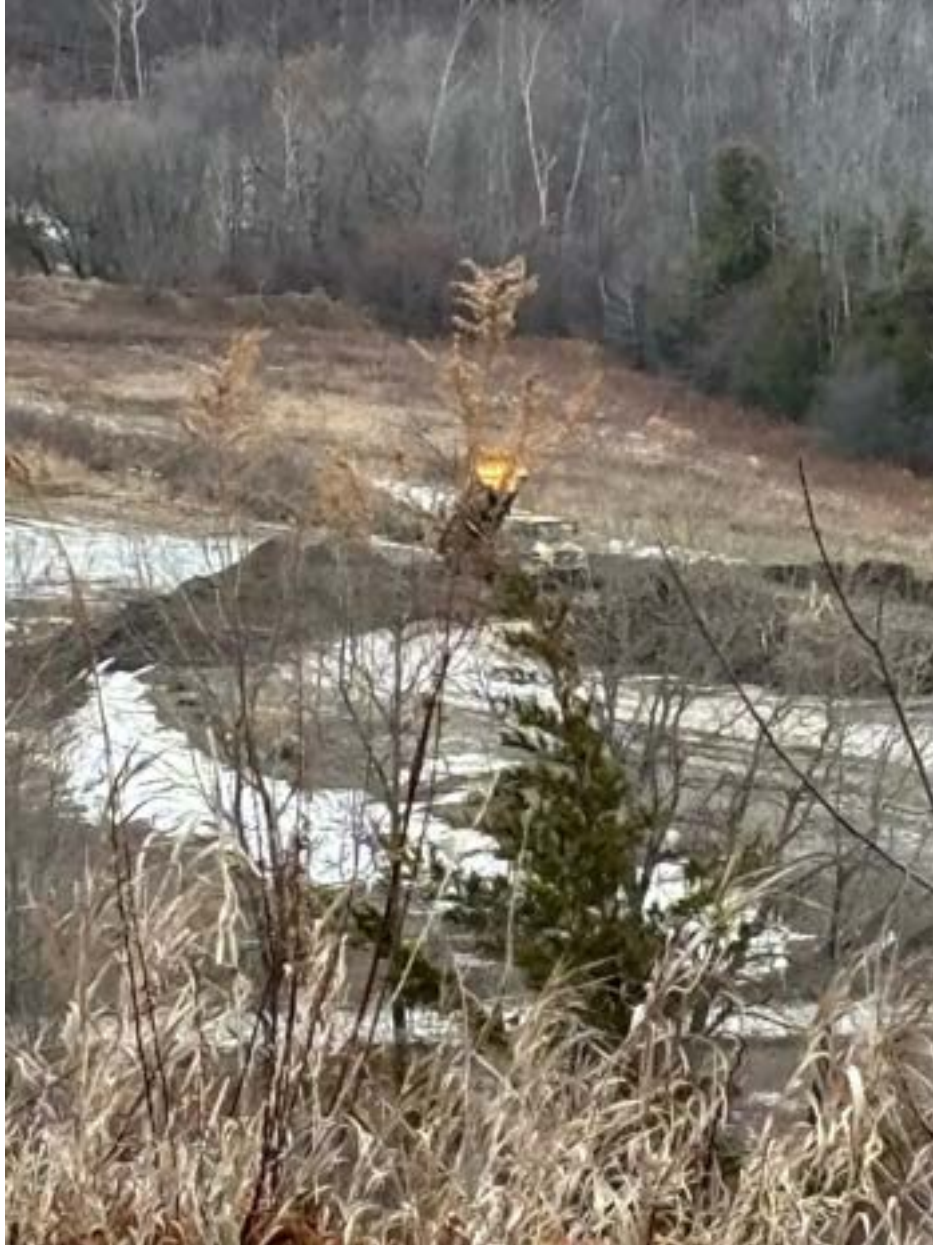
4.3.2 Picture taken December 16, 2024, shows the dumping of fill next to the Environmental Zone. Ground Water has resurfaced.

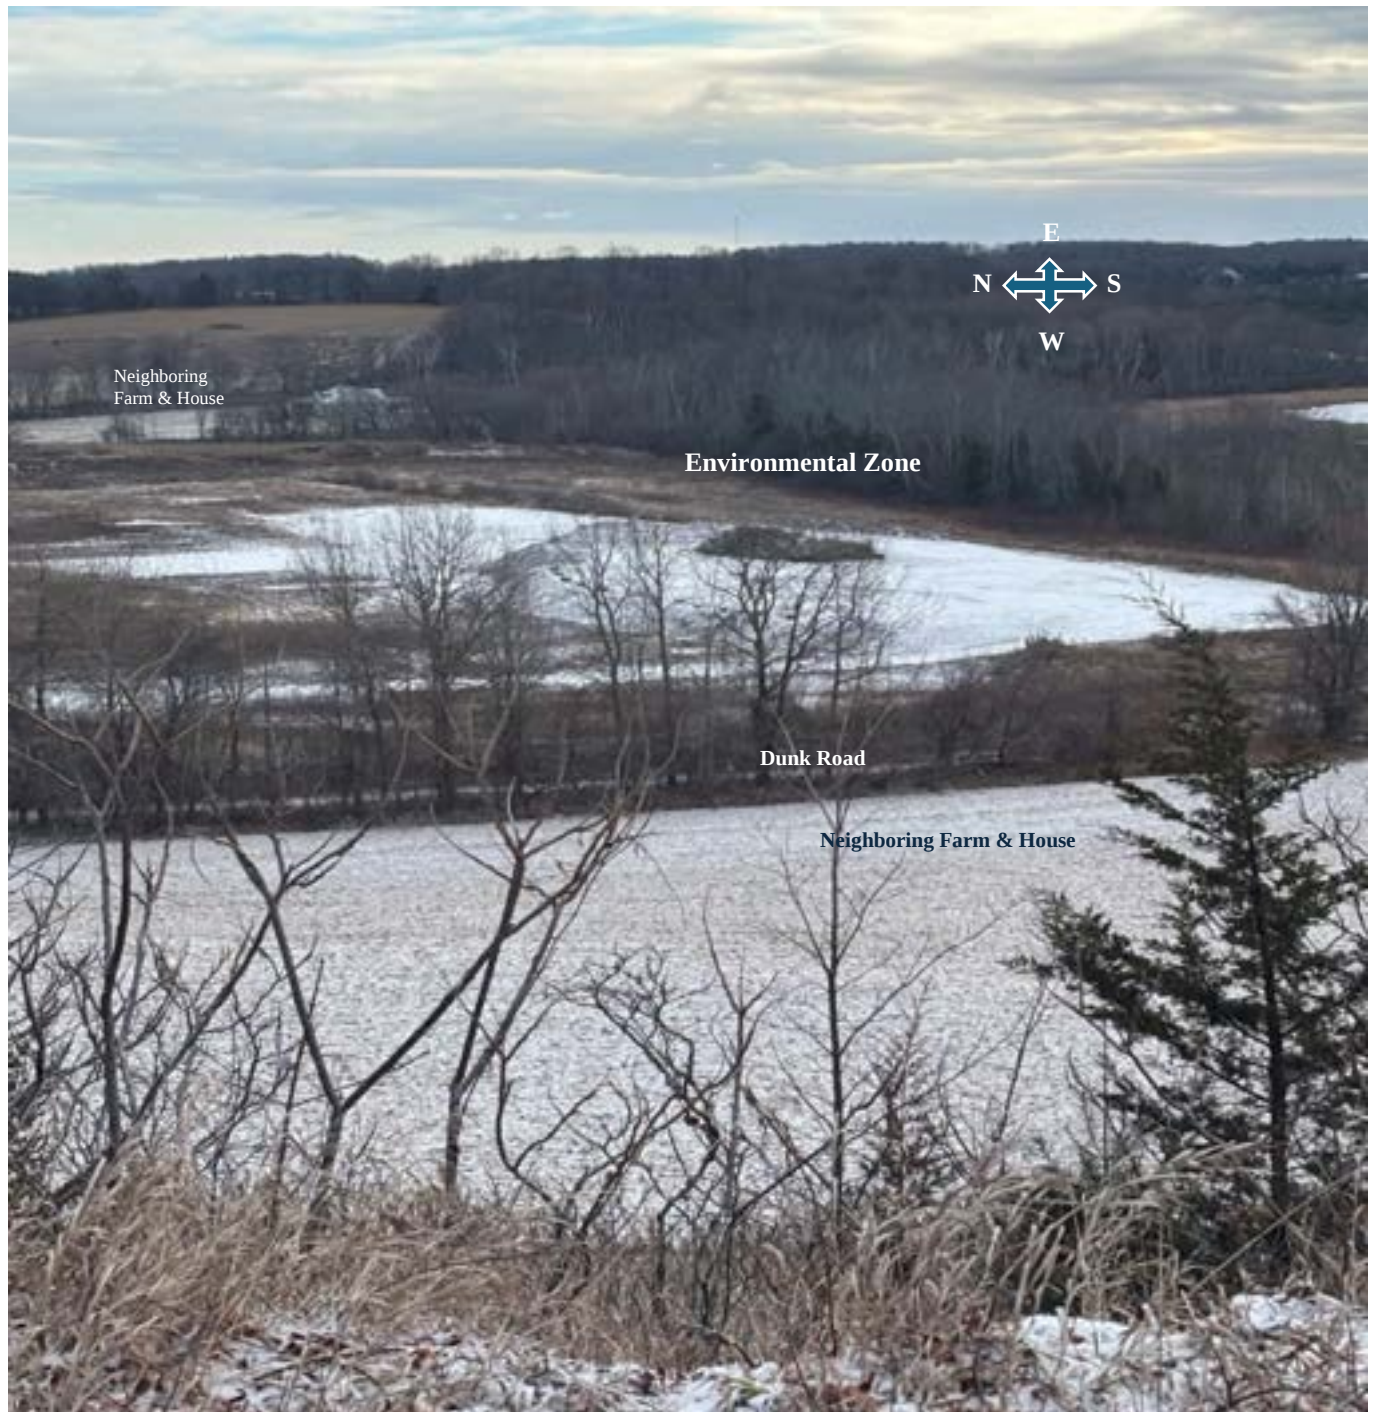
4.3.3 Picture taken December 26, 2024, shows the persistent ground water regardless of fill activities.

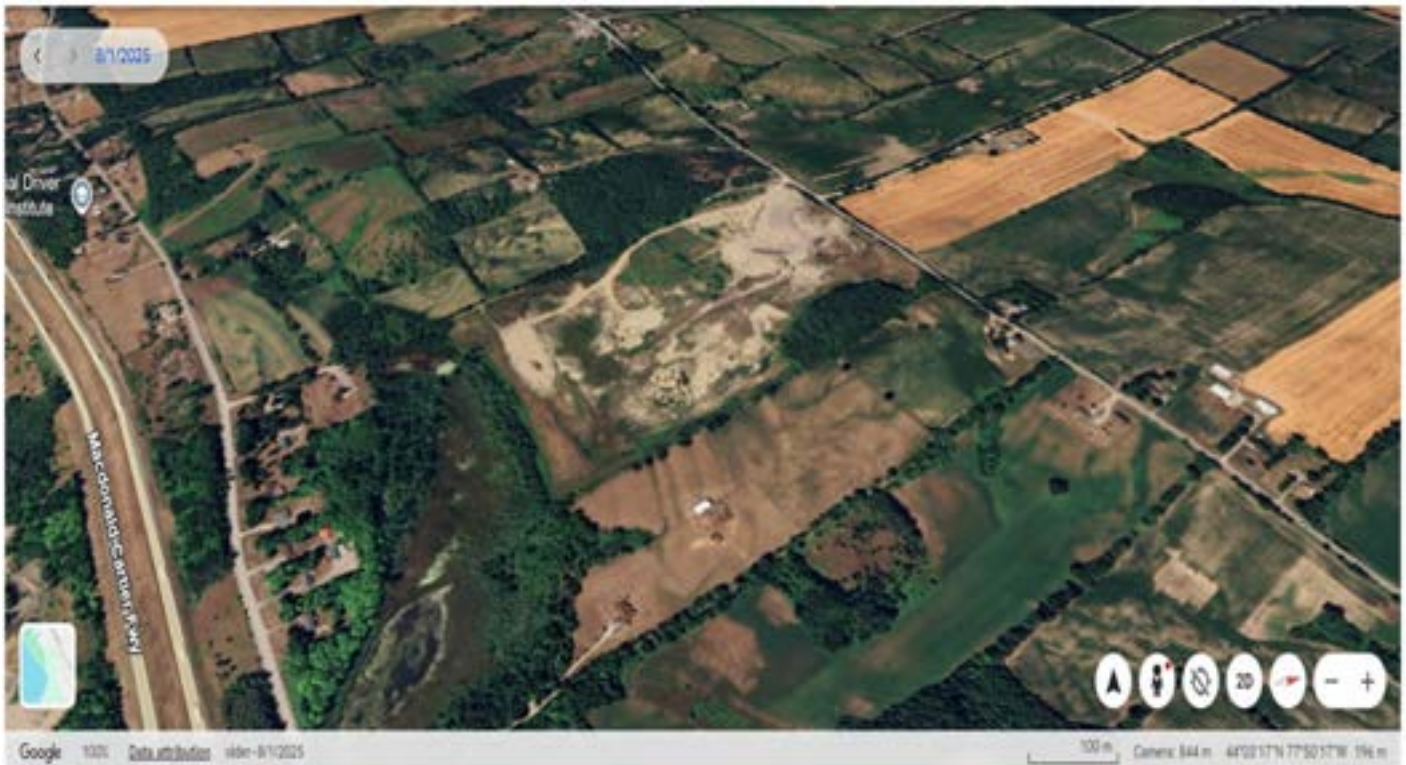
#### 4.4a Aerial Photographs dated August 1, 2025 (Google)

Further, the photographs included in Schedule 4 below (photos 4.4), show that this same pooling continued to appear regularly on the Property, including as recently as the extremely dry summer of 2025. This strengthens our belief, both that the cause of this pooling is indeed aggregate extraction below the water table limits, rather than seasonal surface run-off, and that it has continued un-remediated since the Owner took over the Property from the Prior Owner.

- 4.4 Two aerial photographs, taken in August of 2025, clearly show that despite the intervening drainage and fill activities by the Owner and Prior Owner, brackish ground water was still present on this date, even near the end of an extremely dry summer. On the ground, at this time, we could observe that the level of this ground water was approximately the same as the pond slightly further to the south east, which is part of the protected Biddy Creek Environmental Conservation

In August of 2025 infilling and a drought created dryer conditions but the water still surfaces at the southern pit site.

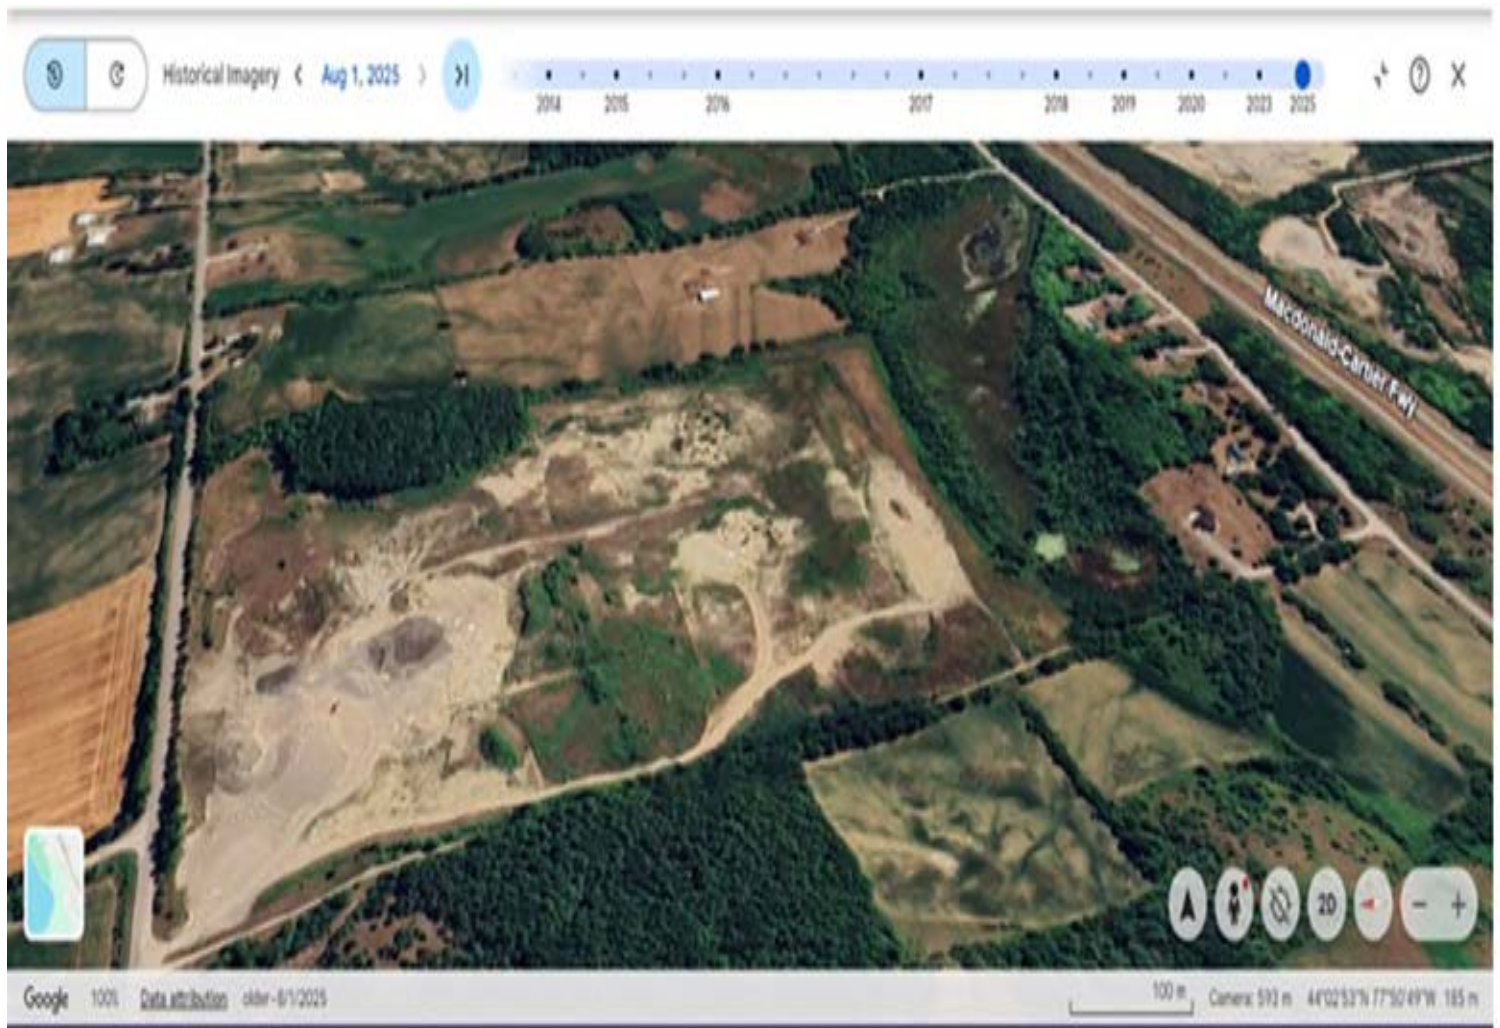
#### 4.4b Aerial Photograph dated August 1, 2025 (Google)

Area. These observations further strengthen our belief that the surface pooling is a result of excavation and aggregate extraction close to or below the water table, and that the activities of the Owner and Prior Owner since these surface pools appeared are not proper remedial activities that would be required if the appropriate site remediation plans were prepared for Ministry approval.
